# Interagency Aviation Safety Alert

No. IA 08-08

July 29, 2008

**Subject:** Immediately Inspect Swage Fittings on All Rappel Ropes  
**Area of Concern:** Rappel Operations  
**Distribution:** All Rappel Bases

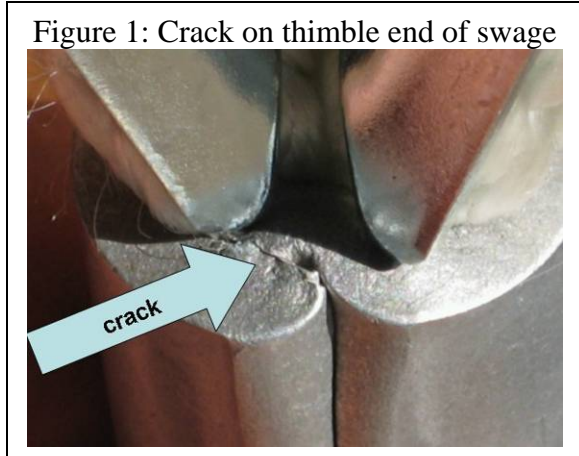
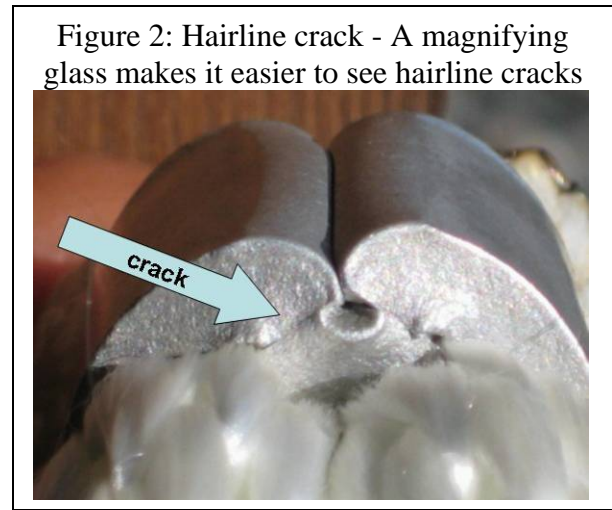
**Discussion:** A potential safety issue has emerged concerning the ½ inch Descent Control ropes used in helicopter rappel operations. A number of the aluminum swages used on rope terminations have been found to have cracks running lengthwise through the bodies of the swages. No swages have been reported as having failed during use.

- 1) All rappel rope swages should be carefully inspected by a qualified spotter. The cracks can only be seen by inspecting both of the flat ends of each swage (figure 1 and 2).
- 2) Any rope identified as having cracked swages or suspected cracked swages should be removed from service immediately and sequestered.
- 3) Report any ropes with cracked swages or suspected cracked swages to your regional Interagency Helicopter Rappel Equipment and Procedures Committee representative. Procurement dates and copies of rope logs should accompany each rope identified as having cracked swages.
- 4) **Information will be forthcoming on what to do with ropes removed from service; in the interim, do not ship ropes with cracked swages to High Angle or Descent Control.**

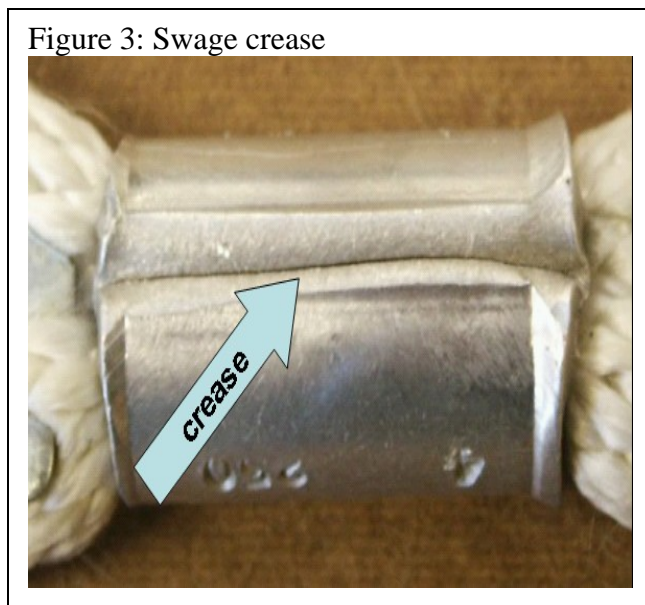
**Background:** All swages have a crease down each side as a result of the crimping process used to press swages onto ropes (figure 3). When looking straight down on them, these creases may look similar to cracks, but when viewed end-on, the crack should not extend through the body of the swage.
