No. IASA 14-01 MAY 15, 2014 Page 1 of 2

**Subject:** Gunner Strap & Tether Rigging

**Area of Concern:** Helicopter Operations

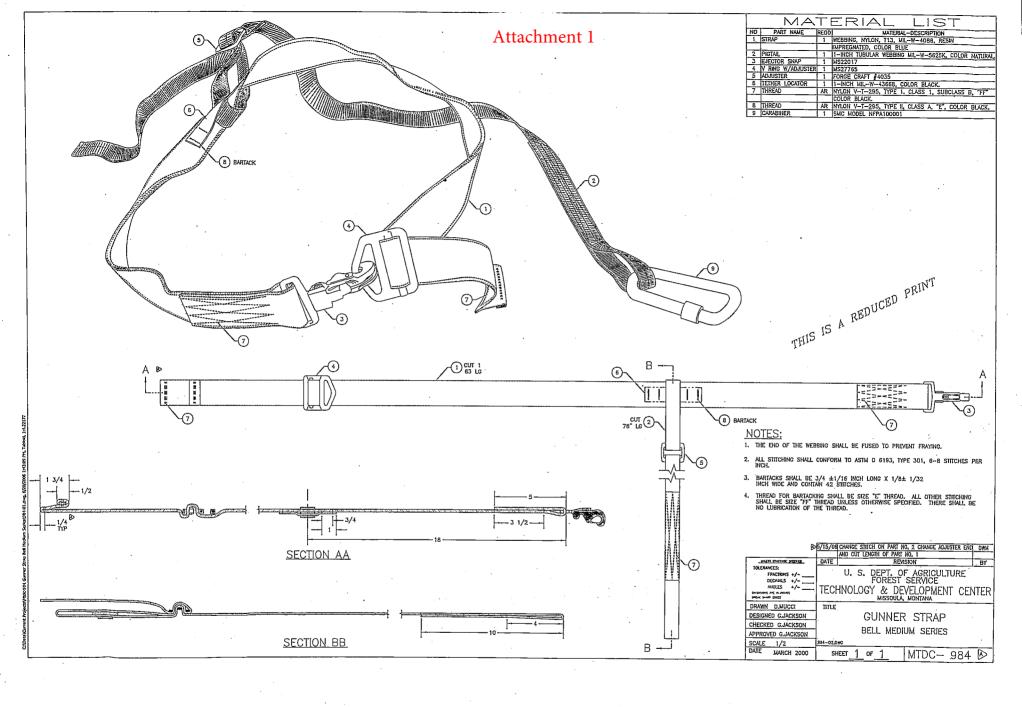
Figure 1 (Attached Correctly)

To properly rig the gunner strap, route the tether through the adjuster buckle making sure the webbing passes over the center (ridge) portion of the adjuster buckle. Then route the tether around the gunner strap and through the tether locator (Attachment 1 MTDC-984). Pass the tether back through the adjuster buckle in reverse order and make sure there is enough slack to finalize the connection with a locking stow (Attachment 2 MTDC-993). When adjusted properly, the adjuster buckle should be located within approximately one inch of the gunner strap (Figure 1).

- 1. Immediately inspect all Gunner Belts and ensure the tether is attached in accordance with the drawing in MTDC-984 (Attachment 1)
- 2. Immediately inspect all tether straps ensuring correct threading with a finalized locking stow on the buckle in accordance with the drawing in MTDC-993 (Attachment 2)
- 3. Immediately inspect all tether straps to ensure the adjuster buckle is located NO FURTHER than one inch from the gunner strap (Figure 1)
