Lessons Learned

No. DOI LL10-03

Subject: Boats & Planes Don't Mix

Area of Concern: Floatplane Operations

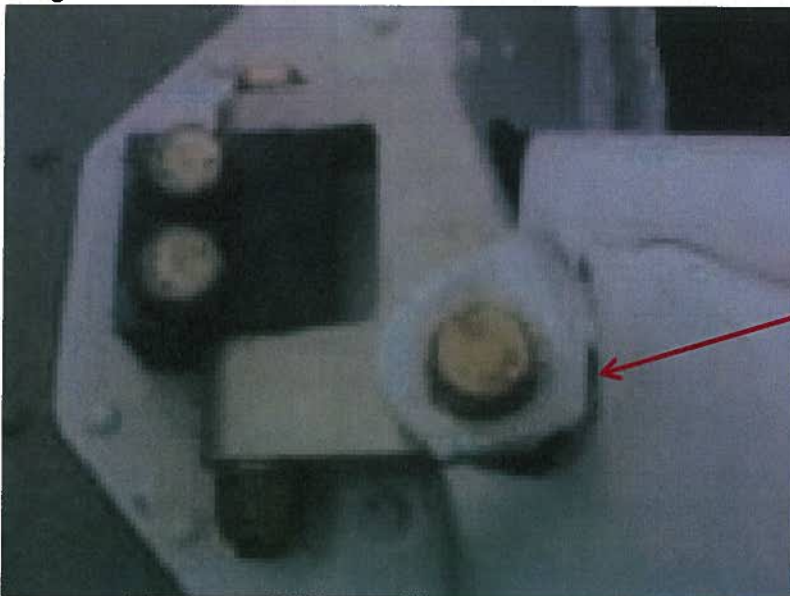
Figure 1

Discussion: On August 11, 2010 an aircraft equipped with Whipline straight floats attempted to take off from the water when it struck the wake of a passing boat. The boat had previously crossed in front of the aircraft's departure path causing the pilot to abort the take off and the boat operator to take evasive action. As the boat departed, the pilot initiated another take off and while on the step, struck the boat's approaching wake. The pilot experienced a sharp sound and jolt when the left forward portion of the float struck the boat's approaching wake. Soon afterwards, the aircraft struck the boat's following wake resulting in a softer impact. The aircraft successfully lifted off and completed a 3 hour survey. Fortunately, the aircraft was already scheduled to land at an FBO to complete its required 100 hour maintenance inspection. Upon securing the aircraft, the pilot noticed the front left diagonal float brace had failed. Further investigation revealed the attachment point of the brace at the float fitting was bent 90 degrees and one of the two attachment points had completely failed.

Engineers at Wipaire are aware of a similar failure that occurred on at least one other Husky aircraft resulting from an impact outside the anticipated maximum service loads. As a result, Wipaire Engineers are in the process of revising the strut (PN 21A02000-223) that will strengthen the attachment area. Unfortunately, this may result in transferring impact loads to the airframe.
