Department of the Interior Accident Prevention Bulletin

No. DOI APB 15-01

Subject: Aircraft Fuel Pump Cold Weather Kit

Area of Concern: Aircraft refueling

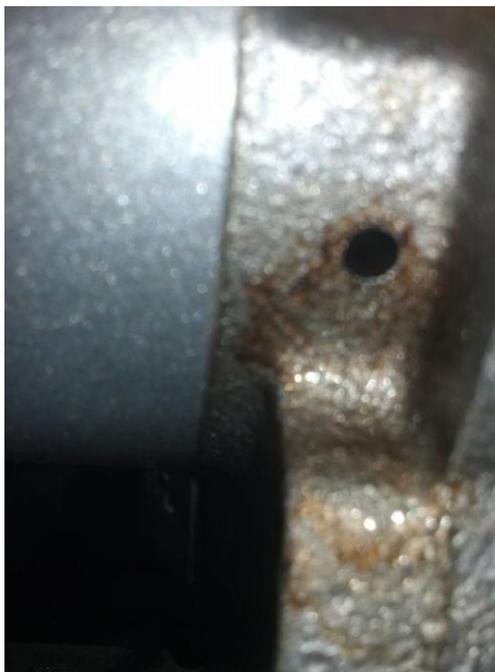
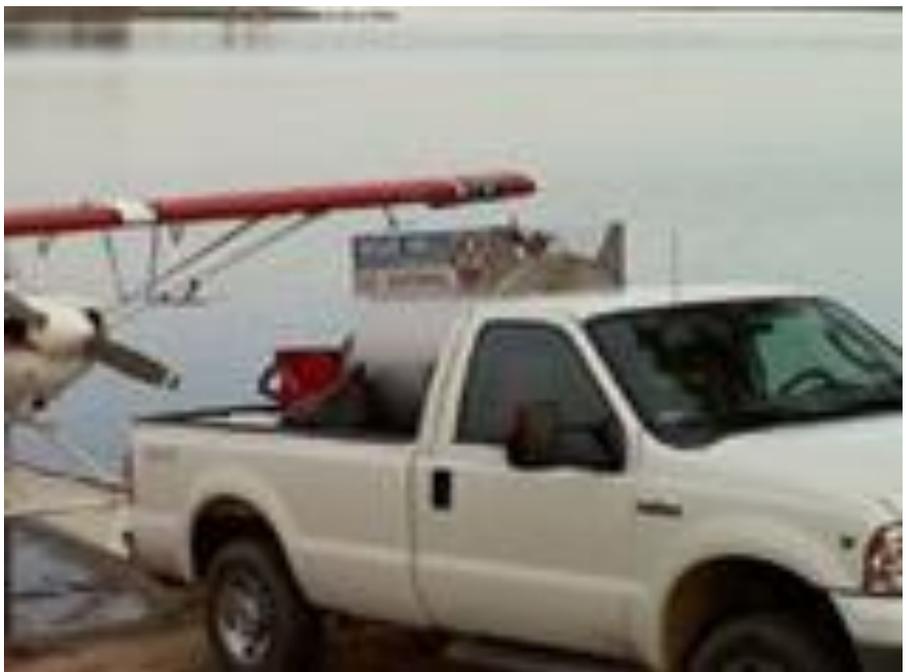
While refueling an airplane from a truck mounted tank using an electric fuel pump manufactured by Great Plains Industries (GPI) with temperatures below zero, the pilot noticed a fuel leak from what appeared to be a bleeder hole on the bottom of fuel pump.

The leak progressed from a drip to a steady flow. Concerned about static electric spark hazards, the fuel truck was taken out of service until the fuel pump repair was complete. The pilot took pictures of the pump and the location of the leak and sent them to GPI for analysis where they identified the problem as a broken shaft seal. GPI stated that the fuel pump was equipped with a standard shaft seal kit, not a cold weather seal kit. The cold weather shaft seal kit (part number 133503-04) was installed and the fuel truck was returned to service.

According to a product support representative from GPI, the new part number is 133503-05. The standard seal is rated from -13°F to 104°F. The cold weather seal is rated from -40°F to 104°. The the two seals differ in materials and the cold weather seal has a slightly different design.

Winter is almost upon us. If you are going to be conducting aircraft refueling operations in very cold weather environments using a GPI fuel pump, check to see if the pump you are using has the cold weather shaft seal kit installed. Don't let Old Man Winter keep you from flying.
