Interagency Aviation Accident Prevention Bulletin

No. IA APB 18-05

Subject: UH-1H Tail Rotor Pitch Change Quill Assembly Inspection Criteria

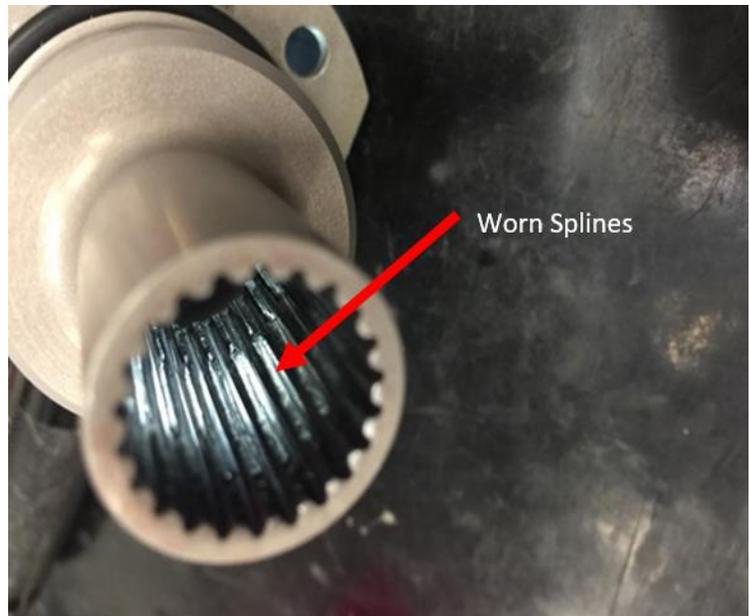
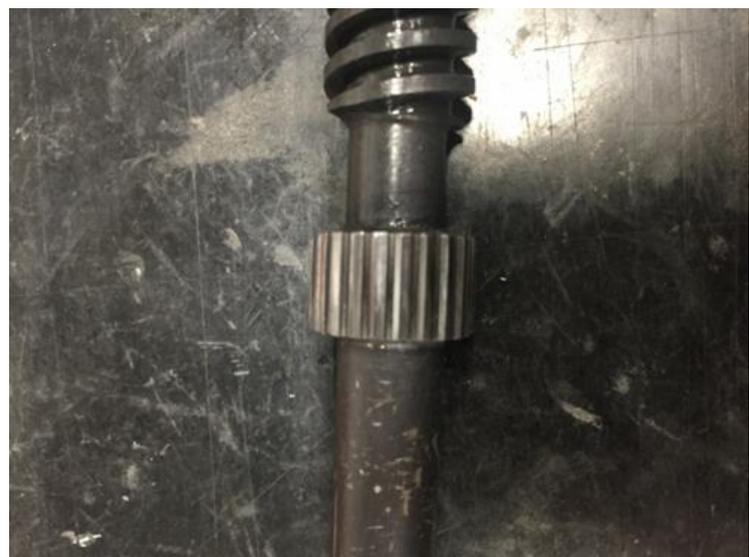
Three aircraft were inspected in accordance with the ICAP inspection and passed the ICAP maintenance requirement, but two of the quill assemblies were worn beyond limits upon visual disassembly inspection. This procedure alone should be considered inadequate due to the fact that it cannot identify wear of all critical components within the pitch control system.

The operators of the helicopters have chosen to continue with the ICAP inspection of the tail rotor assembly. However, in addition, they have implemented the Army requirement for disassembled

visual inspection of the interior quill assembly housing every 150 flight hours to avoid operations on excessively worn parts.

The Forest Service and DOI recommend all operators of these aircraft implement both ICAP and US Army inspection protocols to ensure airworthiness.
