Interagency Aviation Lessons Learned

No. IA LL 20-02

Subject: Aviation Life Support Equipment (ALSE)

Area of Focus: Helmet Visors

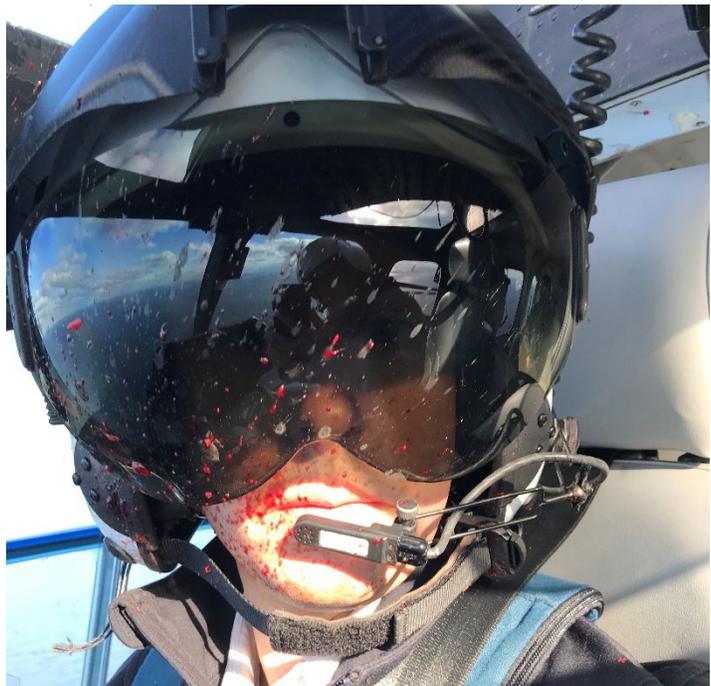
A contracted pilot and aircraft was transporting two Inspectors to an off-shore platform. At approximately 60 miles off shore, the pilot noticed a bird in front of them and took evasive action, but the bird turned toward the aircraft and impacted the pilot's door post. The impact broke off an 18-inch piece of the windshield trim and bent the pilot door leading edge which created a gap large enough for the bird to enter the aircraft.

According to the pilot, the amount of bird splatter inside the aircraft was significant but most of the larger pieces of the bird continued past his right side, making impact with the lower aft portion of the pilot door window. The window broke, allowing the rest of the bird to exit the aircraft.

The pilot received the most splatter from the bird as it hit the frame of the pilot's door, entered the aircraft and exited through the lower door window. Had the pilot's visor been up, he could have sustained serious injury to his eyes and ultimately resulted in the total loss of control of the aircraft.

**Helmets should always be worn with the visor down.
ALSE when used correctly, can save your life and others.**

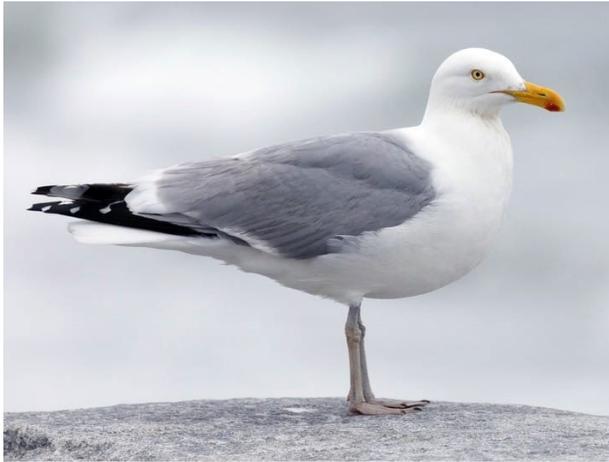
The bird that struck the helicopter was believed to be a Herring gull. The average weight of a Herring gull is two pounds. With the helicopter travelling at 135 knots, the bird strike kinetic energy was approximately 1,619 foot pounds, the same impact energy produced by a .22-250 Remington round. It's evident from the photos of the damaged aircraft, that the bird hit the helicopter with the equivalent impact energy of a .22-250 Remington round.
