Interagency Aviation Lessons Learned

No. IALL 17-01

Subject: Bell 206 B3 Ground Operations

Area of Concern: Potential For Aircraft damage

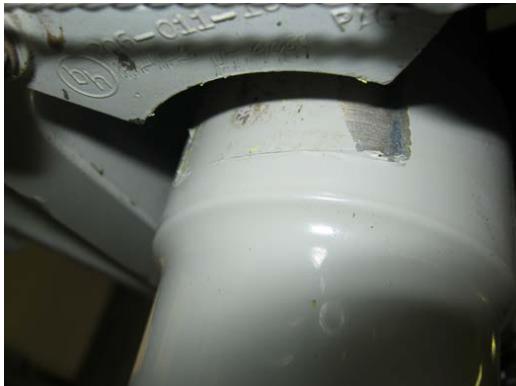
Main rotor mast.

The Bell 206 B3 helicopter is fitted with a teetering, two-blade main rotor system. The teetering design allows the main rotor blades to flap to compensate for asymmetrical lift during flight. One static stop is mounted on either side of the main rotor hub to physically limit the amount of blade flapping when static. A condition known as “mast bumping” occurs if the static stops contact the mast due to excessive blade flapping during ground operations or in flight. Mast bumping will also occur during ground operations if the cyclic is incorrectly positioned or is moved sufficiently to tilt the rotor disc to an extreme position. If the static stop to mast contact is severe, pronounced helicopter oscillations may develop and the helicopter can sustain substantial damage. In flight, this type of damage can result in the main rotor system separating from the helicopter.

The corrective action is to immediately reposition the cyclic toward or near the neutral position so that the rotor disc resumes a flat (centered) position. During reduced or idle RPM, the rotor disc is less stable and more susceptible to larger deviations due to flapping.

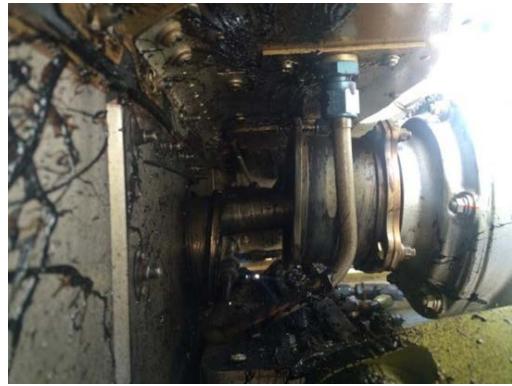
Main rotor drive shaft coupling.

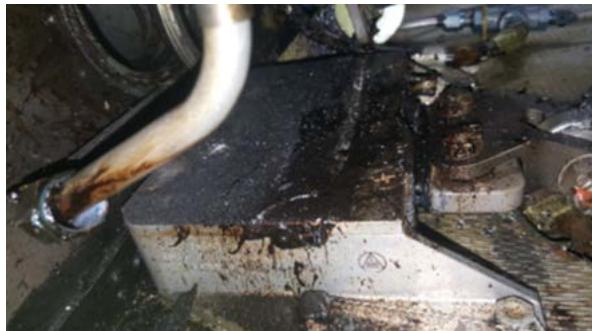
Isolation mount.

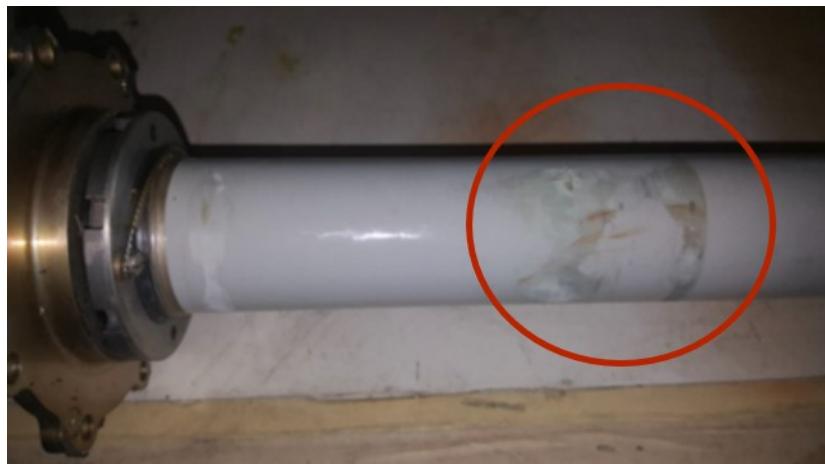
Contact marks on main rotor mast.
