Department of the Interior Lessons Learned

No. DOI LL 16-03

Subject: UAS Mishap Lessons Learned

Area of Concern: UAS Operations

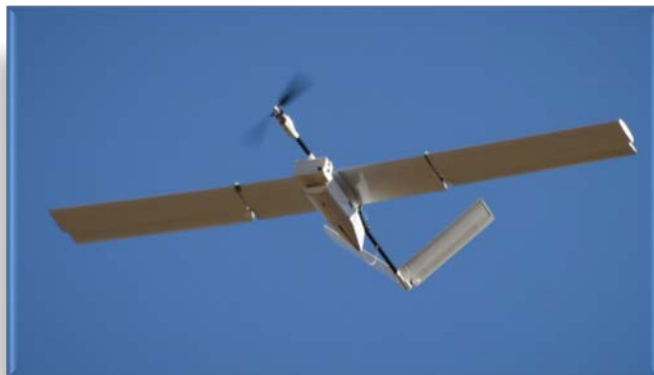
What happened? A DOI bureau was conducting UAS operations using the Falcon Fixed-wing sUAS to photo map terrain.

The Falcon proceeded to the first waypoint and began a turn of approximately 180 degrees in order to track the appropriate mapping transect in the opposite direction. During the turn, aircraft control was lost suddenly and it fell into a nosedive without any input from the pilot. The pilot maintained visual contact with the aircraft as it was about 1.2 km from the launch location.

The pilot depressed the parachute deploy button on the hand controller multiple times but the parachute failed to deploy and the aircraft impacted the ground in a nose low attitude. The aircraft was successfully located, recovered, and subsequently repaired.

The aircraft received substantial damage to the airframe but did not qualify as an accident due to the 300 lb. threshold required by NTSB regulations (49 CFR 830). No personnel were injured, but the mishap was declared as an Incident With Potential (IWP) by the OAS Chief, Aviation Safety, Training, and Program Evaluations.

- 1. Thorough Preflight.** The UAS center wing section was not fully seated during the preflight. A bent electrical pin didn't allow for the wing to seat or fully contact the wing's electrical connector. This caused an intermittent electrical connection to the aileron servos during flight. This same connection also provides power to the position lights, which failed to test correctly when the crew conducted the automated preflight check. The inoperative lights (although not required for this mission), was a leading indicator that something was not connected correctly.

This intermittent connection eventually resulted in to a complete flight control failure and subsequent loss of aircraft control. The crew did not quickly identify the flight control anomalies. In this sequence, they had approximately 15 seconds from the onset of the anomaly to where they could deploy the landing parachute in time to avoid impacting the terrain. Had they identified the loss of control situation sooner, they may have been able to deploy the parachute in time to recover the UAS and avoid damage.

2. **Maintain Visual Contact.** Both the Pilot and the Ground Control Station (GCS) operator must monitor the UAS - the Pilot visually and the GCS operator through the GCS display. The Pilot must operate the UAS by “Visual Line of Sight.” This requires that the UAS be visible at all times to the pilot. This distance is not absolute as conditions such as terrain, weather, and viewing angle can all cause changes in how well the pilot can see the sUAS and how far away you should allow it to go. The sUAS was 1.2 km (.75 miles) away, which may have contributed to their inability to identify rapidly its loss of altitude or other anomalies. Operators should adjust distance as needed to monitor attitude and the environment better where the UAS is operating.

3. **Reduce Glare.** The GCS operator may have had difficulty monitoring the status of the UAS due to the sun glare on the computer screens. The GCS consists of commercially available computer monitors that have glossy screens and are highly reflective. During days with bright, direct sunlight, the glare and reflections on the screen significantly inhibit aircraft monitoring and other critical information. Operators should strongly consider using sunshades that shade the monitors, wear darker and lower reflective clothing, and orient the computer monitors to minimize glare from the sun. Modifications to monitors and future systems may include anti-glare filters.
