Lessons Learned

No. DOI LL10-03

Subject: Boats & Planes Don't Mix

Area of Concern: Floatplane Operations

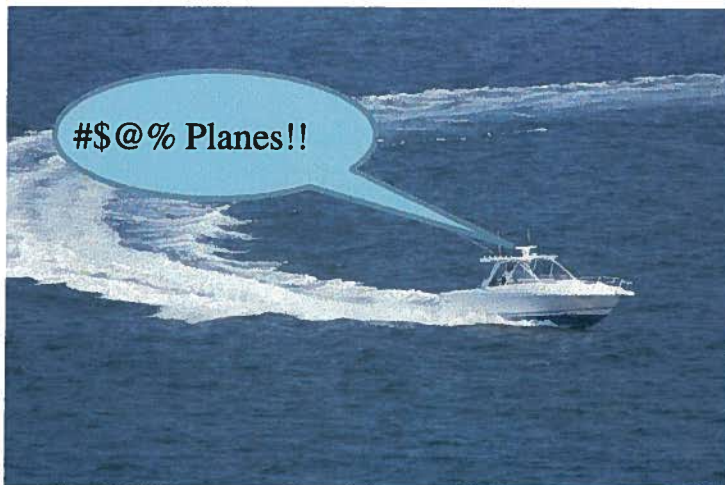
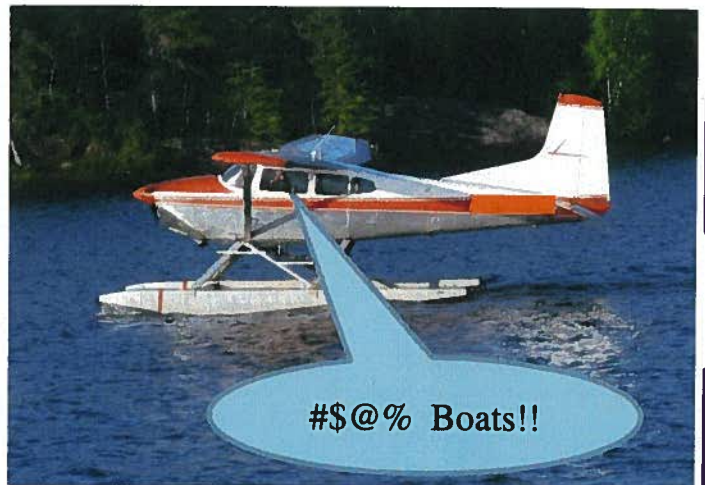
Discussion: On August 11, 2010 an aircraft equipped with Whipline straight floats attempted to take off from the water when it struck the wake of a passing boat. The boat had previously crossed in front of the aircraft's departure path causing the pilot to abort the take off and the boat operator to take evasive action. As the boat departed, the pilot initiated another take off and while on the step, struck the boat's approaching wake. The pilot experienced a sharp sound and jolt when the left forward portion of the float struck the boat's approaching wake. Soon afterwards, the aircraft struck the boat's following wake resulting in a softer impact. The aircraft successfully lifted off and completed a 3 hour survey. Fortunately, the aircraft was already scheduled to land at an FBO to complete its required 100 hour maintenance inspection. Upon securing the aircraft, the pilot noticed the front left diagonal float brace had failed. Further investigation revealed the attachment point of the brace at the float fitting was bent 90 degrees and one of the two attachment points had completely failed.

Item	Description	Cost
Labor	Removed and replaced forward strut assembly	\$210.00
Labor	Removed forward left-hand and right-hand strut attach fitting, checked left and right hand forward fuselage attach points by Dye Penetrant Checking, reassembled.	\$240.00
	Strut Assembly Forward Painted	<u>\$368.20</u>
Total Cost:		\$818.20
