Interagency Aviation Lessons Learned

No. IA LL 11-05

Subject: Wire Strike Protection Kits

Area of Concern: Helicopter Operations

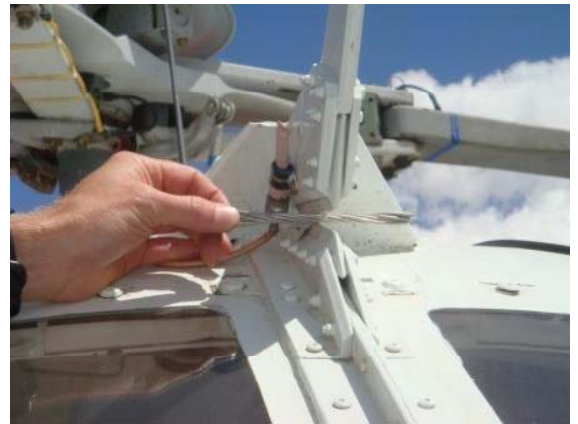
Discussion: Recently, a vendor helicopter struck and severed two power lines while landing at a temporary refueling site. The selected landing site was a gravel and asphalt parking area used by the state highway department located at the intersection of two highways.

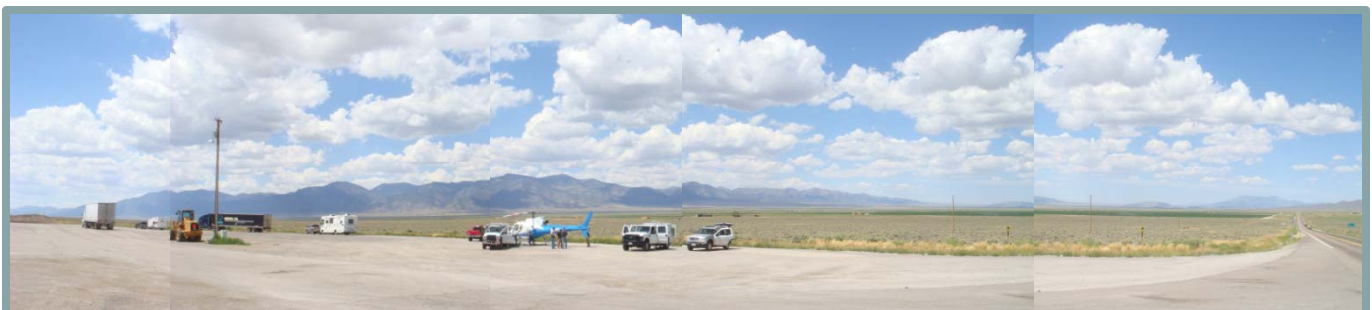
There were two 8 strand, 1/4" diameter power lines attached to the top of the power pole. The lines were approximately 4 feet apart and sloped down to the power poles located on the northwest edge of the parking area. The light grey color of the wires and the grey clouds over the distant mountains made it practically impossible to see the wires.

The pilot entered the final approach path and descended to an altitude of approximately 30 feet AGL placing the aircraft at a similar height of the power lines. **Due to the pilot's intense focus on the landing area, moving vehicles and environmental factors, he was unaware of the wires or the power poles.**

The helicopter impacted the power lines at an airspeed of less than 5 knots and cut them with the top wire strike protection kit installed on the aircraft. The pilot stated that he felt a slight tug as he cut the first wire and after cutting the second power line, looked to the left and saw the power pole. Realizing what had just happened, he backed the helicopter up then landed. Fortunately, there was no injury to the pilot or damage to the helicopter. Had it not been for the wire strike protection kit, the power lines could have become entangled in the main rotor system with catastrophic results. According to Helicopter Association International (HAI), wire strikes are the number one cause of helicopter accidents and account for 40% of all fatal accidents. While there is no requirement for ground crews to be in place prior to a helicopter's arrival, it might have prevented the wire strike from occurring in the first place.

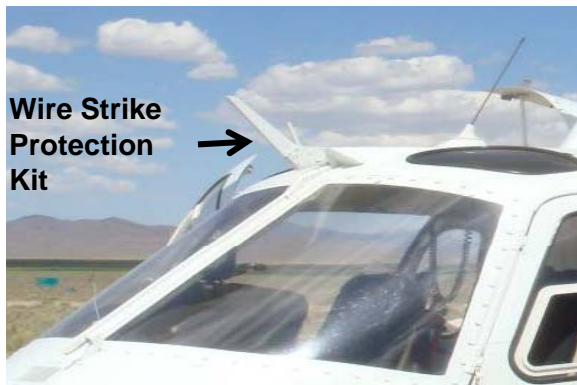
← Having this

The wire strike protection kit is the last defense against wire strikes. A comprehensive mission brief to include known hazards annotated on a hazards map, a thorough risk assessment of refueling areas, and maintaining situational awareness is your first line of defense. But when all else fails, it's good to have a backup.
